Technical Service Bulletin

No.LM303-002
05 October 2004

Subject/Concern: Range Rover (LM) - High Engine Speeds and/or Transmission Shift Problems

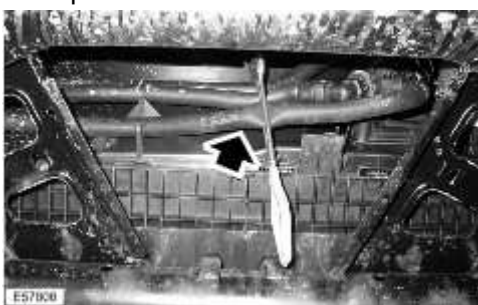
- 4 . Remove the coolant expansion tank cap.
- 5 . Remove the under-tray For additional information, refer to Global Technical Reference (GTR) New Range Rover Workshop Manual Section Exterior Fittings, Undertray - front (76.11.81).
- 6 . Clamp the lower sub cooler hose.

- 10 . Remove the clamp from the lower sub cooler hose. Refer to illustration in 6.

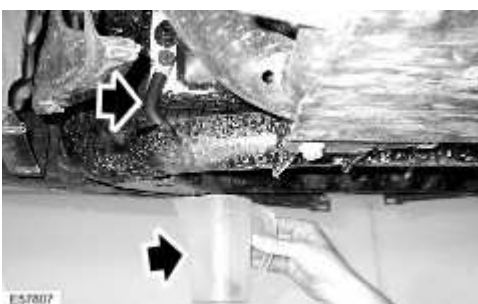
- 7 . Install a tube to the drain tap and position a measuring container beneath the radiator to collect coolant .

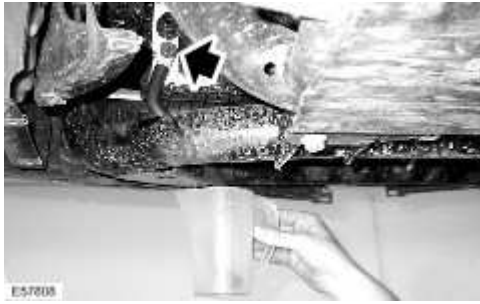
- 8 . With the aid of a timing device, fully open the drain tap and allow 250ml of coolant to drain and note the time taken to drain the amount before closing the radiator drain tap. The time taken to drain 250ml of coolant will indicate the existence of blockage within the low flow circuit of the radiator. For guidance, indicative times are listed: New radiator (zero blockage) - 10 seconds to drain 250ml of coolant. Used radiator (confirmed blockage and exhibiting fault symptoms) - 1 minute 40 seconds to drain 250ml of coolant. **NOTE:** If there is no existence of a blockage in the radiator, top up the coolant level and refit the coolant expansion tank cap, carry out any other diagnostics and associated repairs and claim as a separate Warranty Claim.

- 9 . **NOTE:** Where a blockage of the low flow circuit of the radiator is confirmed, the radiator **MUST** be replaced with a new unit, as it is not possible to clear the blockage.
